Manhole Inspection Summary

Manhole # S35II1003MH

Location Address: **204 LAMBETH RD**

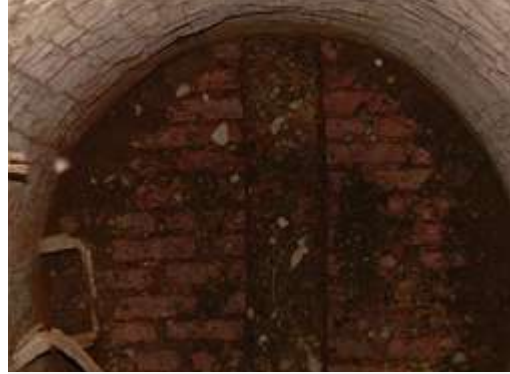
Top View

Condition: ☐ Sound ☐ Cracked ☐ Root Intrusion ☐ Deteriorated ☐ Leaks ☒ **Debris**

Count: **3** Missing: **1** ☒ **Corroded**

Bench and Channel debris. Corroded and missing steps.

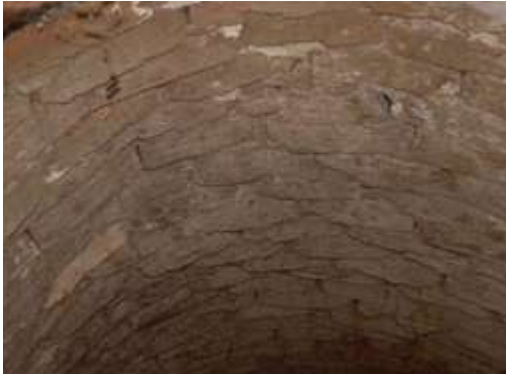
Defect

Condition: ☐ Sound ☐ Cracked ☐ Root Intrusion ☐ Loose Brick ☒ **Deteriorated**

Infiltration: ☐ None ☒ **Joint** ☐ Cracks ☒ **Mortar** ☐ Roots ☐ Wall

Infiltration: ☐ None ☐ Joint ☐ Cracks ☒ **Mortar** ☐ Roots ☒ **Wall**

Adjustment deterioration and infiltration.
Corbel and Barrel infiltration.

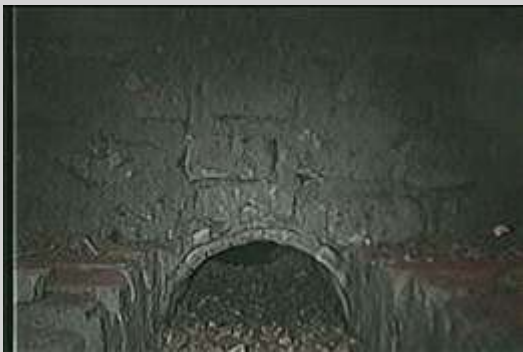
8 in. Circular Gravity Sewer Pipe Out @ 12 O'Clock

Deposits: ☐ None ☒ **Mud** ☐ Sludge ☒ **Debris** ☐ Grease

Silt Depth: **4** (in.) Deposits Extent: **Heavy**

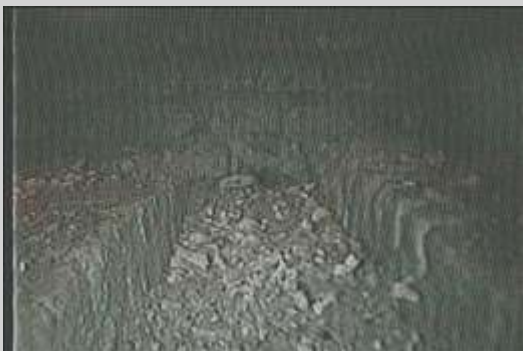
Pipe In @ 6 O'Clock

Barrel deterioration and infiltration.

Deposits: ☐ None ☒ **Mud** ☐ Sludge ☒ **Debris** ☐ Grease

Silt Depth: **5** (in.) Deposits Extent: **Heavy**

Infiltration: **None** Pipe Seal Cond: **Cracked**
